**CONNECTICUT RIVER BASIN  
LITTLETON NEW HAMPSHIRE**

**ICE POND DAM  
N.H.00145**

**PHASE I INSPECTION REPORT  
NATIONAL DAM INSPECTION PROGRAM**

**APRIL, 1979**

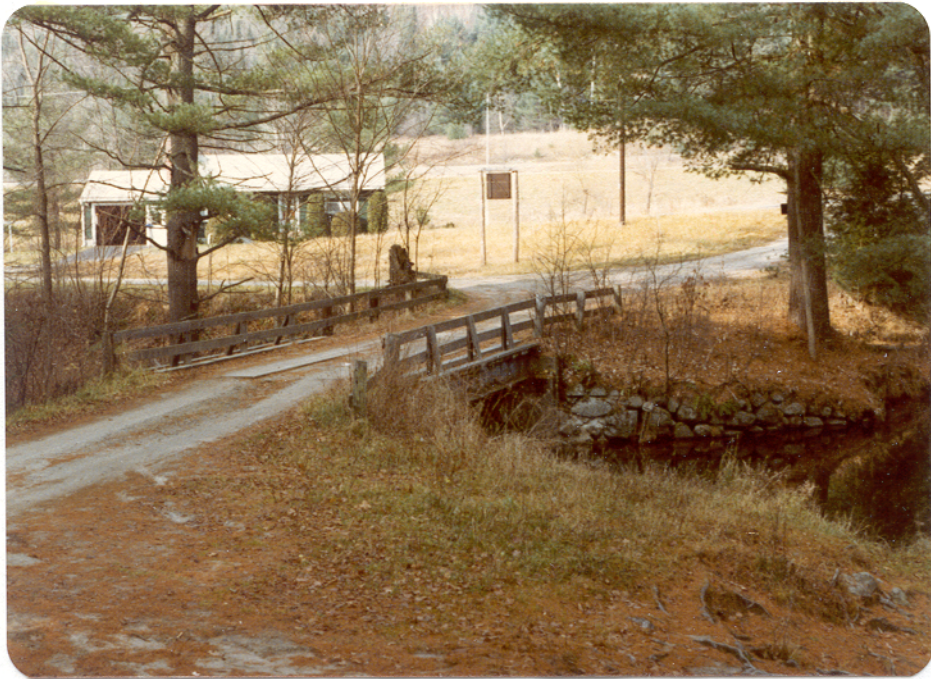
The upstream training walls are stone masonry with several voids and loose stones. Several small trees are growing from the top of the wall (see Photo 1).

#1. VIEW OF TOP OF DAM AND ACCESS BRIDGE  
OVER THE SPILLWAY

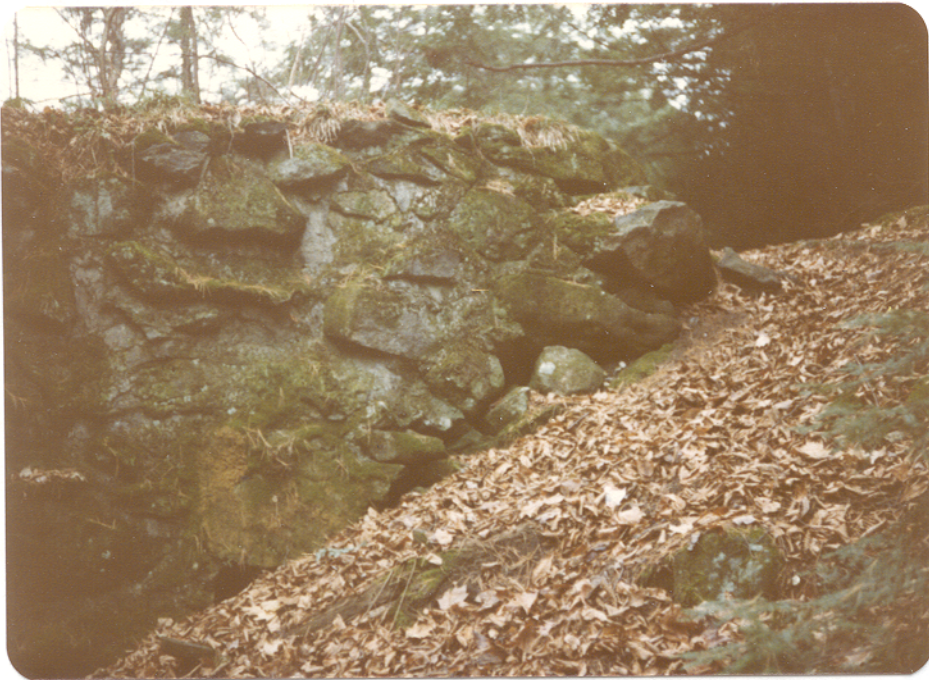
The downstream face of the dam is of stone masonry construction. The surface is irregular and shows no apparent seepage. There is some growth of vegetation out of cracks in the wall. At the left abutment there are some voids in the wall, and apparently some stones are missing (see Photo 2). The cause of the deterioration of the wall at the left abutment is probably erosion due to runoff from the access road. An inspection along the toe of the downstream wall revealed no indications of seepage. There are several trees growing immediately downstream of the dam.

left abutment where the stone wall contacts the abutment (see Photo 2). As noted in Section 3, some erosion has occurred in this area.

#2. VIEW OF EROSION AND SETTLEMENT AT  
LEFT ABUTMENT

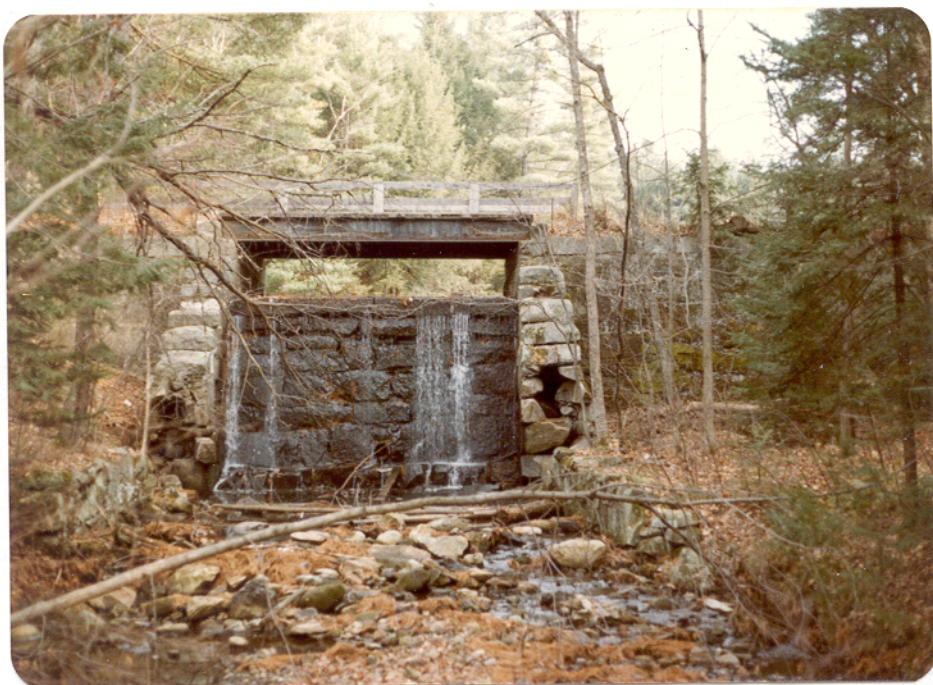
An intake and/or drain structure can be seen in deep water approximately 25 feet upstream of the dam. Contents of the structure could not be determined through the water. It is assumed that the 12-inch drain line terminating at the downstream spillway face (see Photo 3) begins in the structure with a drain valve.

#3. VIEW OF DOWNSTREAM SPILLWAY FACE AND TRAINING WALL

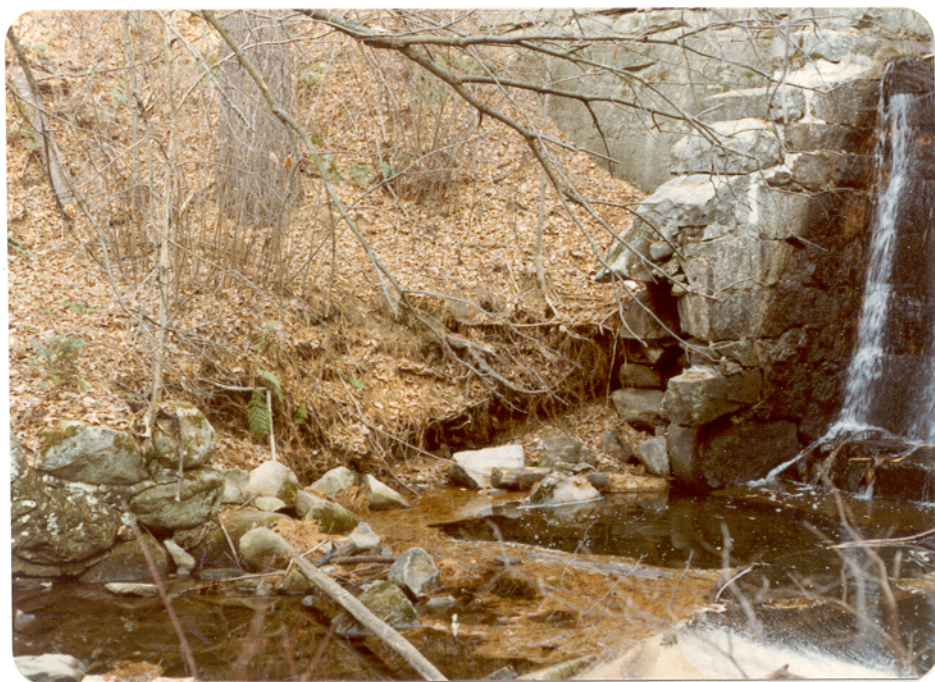
The downstream training walls are in poor condition. High flows over the spillway have eroded the streambed material to the point where the training walls have partially collapsed into the downstream channel (see Photos 4, 5 and 6). It appears that further erosion is likely and complete collapse of the training walls may occur in the near future.

- a. The downstream training walls of the spillway are in poor condition, the downstream end of the walls having collapsed. If the walls continue to collapse closer to the dam, the flow from the spillway can produce undermining of the base of the dam. The severity of such undermining depends on the depth at which the dam is founded and on the type of foundation material.
- b. The roots of a tree growing on the upstream slope and of several trees growing near the downstream wall of the dam can cause seepage channels to develop. A limited sapling growth from cracks on the downstream wall can accelerate deterioration of the wall.
- c. The left end of the downstream wall of the dam has lost some stones.
- d. There are some voids in the left training wall at the spillway entrance.

#4. VIEW OF RIGHT TRAINING WALL SHOWING UNDERMINING AND COLLAPSE

1. Design and construct increased spillway capacity or stabilize downstream face to withstand continuous overtopping.
2. Reconstruct the downstream sections of the spillway training walls to their original configuration with particular attention given to the foundation to prevent future undermining.
3. Repair the left end of the dam.
4. Fill voids in the left wall at the spillway entrance.
5. Activate the 12-inch drain line.

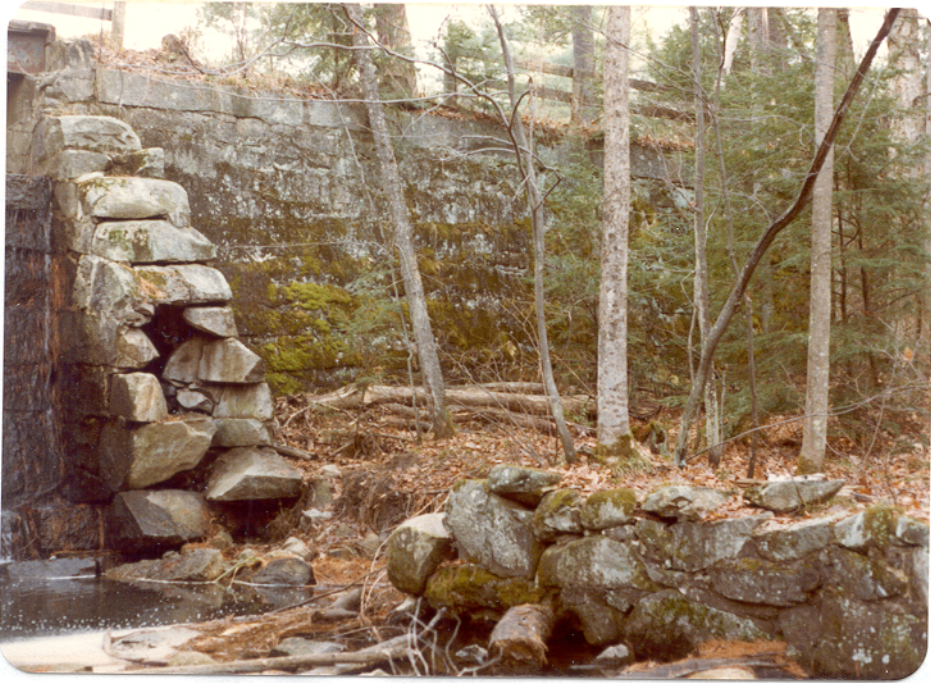
#5. VIEW OF LEFT TRAINING WALL

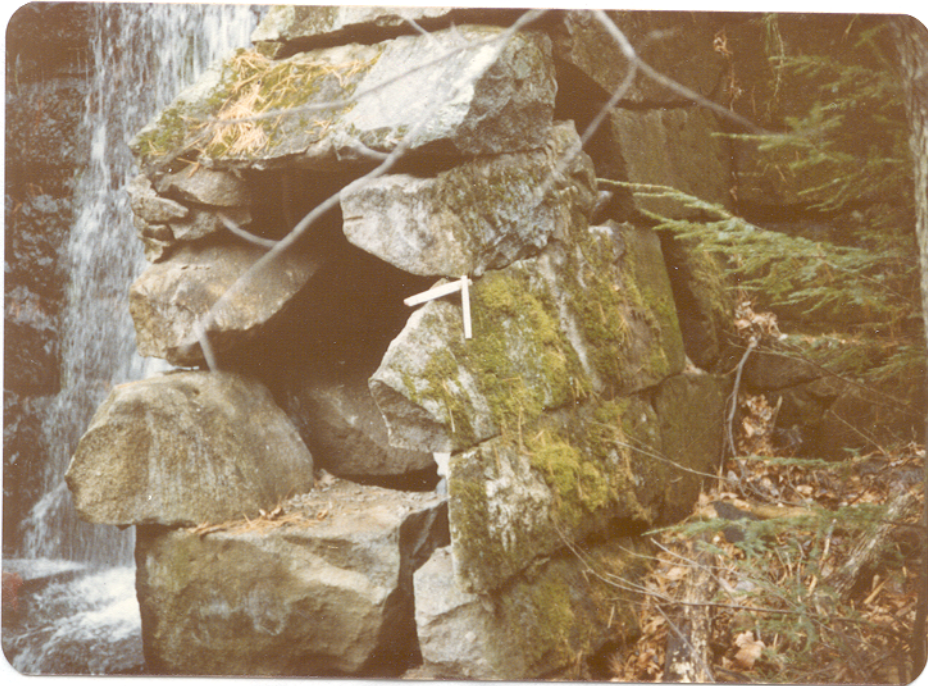
#6. CLOSE-UP OF LEFT TRAINING WALL

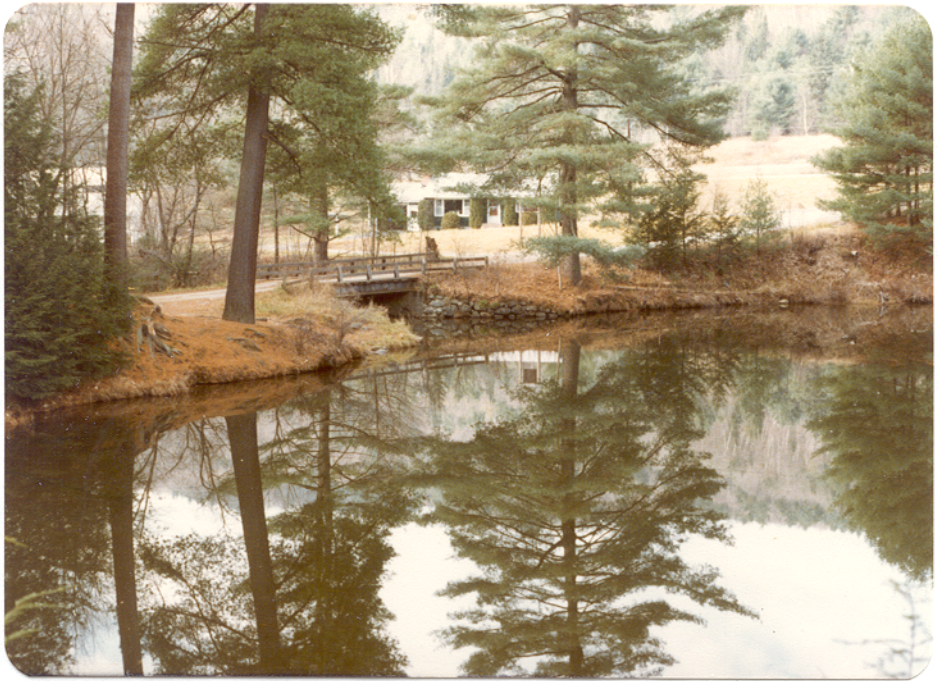
AREA EVALUATED	CONDITION
<u>RESERVOIR</u>	
Stability of Shoreline	Eroding, trees, sandy slope.
Sedimentation	Extensive.
Changes in Watershed Runoff Potential	None known.
Upstream Hazards	None.
Downstream Hazards	
Alert Facilities	None.
Hydrometeorological Gages	None.
Operational and Maintenance Regulations	None.

#7. VIEW OF RESERVOIR AREA

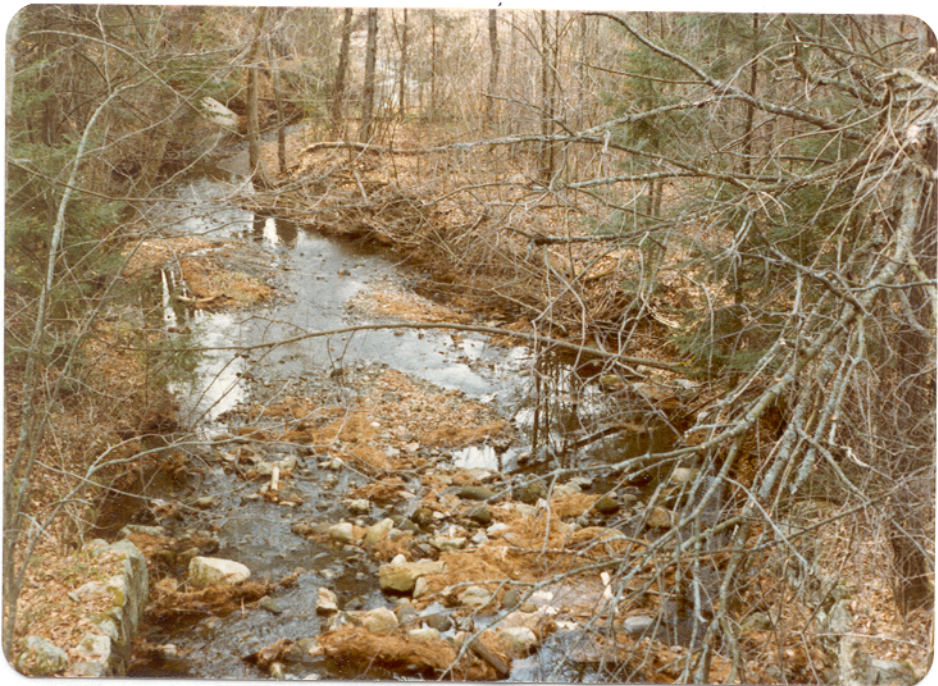
c. Discharge Channel	Channel walls eroded for 10 feet both
General Condition	Poor. Spillway wingwalls partially collapsed and settling, large cracks.
Loose Rock Overhanging Channel	Some.
Trees Overhanging Channel	Yes.
Floor of Channel	Natural stream eroded (no riprap); debris downstream of pool.
Other Obstructions	None.

#8. VIEW OF DOWNSTREAM CHANNEL
